# Conservation Department ADACH Focuses on Historic Building Conservation Activities in Al Ain

#### Emergency Conservation of the Bin Shehail House, Al Ain

#### Conserving the Iron Age Village of Hili 2

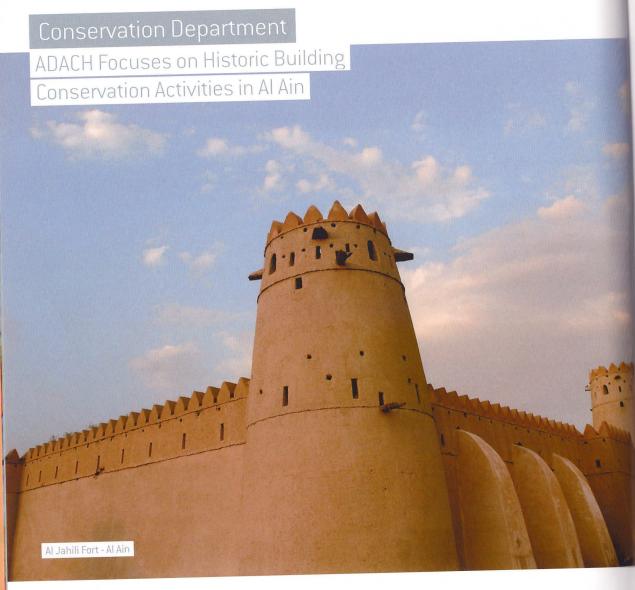
Conservation work on southeast corner of Wing A, in Jahili Fort.

First among these is al Jahili Fort, located next to Jahili Public Gardens, near Al Ain Oasis in the city centre. The Fort consists of a largely intact structure where a full-scale restoration project is being designed and conducted with equal concern to all layers of the building's history. The Strategic Planning Office, in collaboration with the Department of Conservation and the Department of the Historic Environment, is leading the project with the aim to create within Jahili a visitor information centre and a permanent exhibition hall.

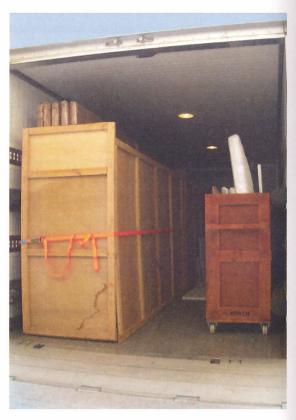
Loading paintings in a climate controlled truck

Preventive conservation is vitally important to mitigating risks to the ADACH artworks by providing proper handling, packing, and transport for each piece of art. In order to minimize handling, each individual artwork was packed and then placed with pieces of similar size in a reinforced box, after which, only the boxes were moved by the specialized art handlers. For the transport, the artworks were moved using a climate controlled truck equipped with air-ride suspension to lessen the physical and chemical stress on artworks caused by vibration and any

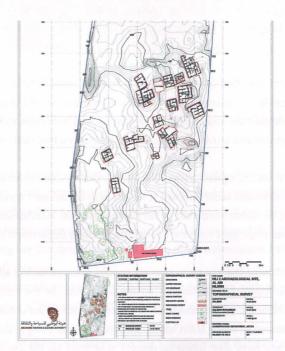
Topographic survey showing the elevation of points throughout the site, and presenting them as contour lines on a plot which indicate depressions or bulges.

Abu Dhabi Tourism & Culture Authority (TCA Abu Dhabi) began addressing emergency conservation issues at Hili 2 this year. Documentation was carried out including a topographical survey of the entire site to understand drainage patterns in critical areas near houses. Total station and digital photography were used for the first time to gather field data related to topographical survey and rectified elevations of houses. Elevations of damaged walls were generated using rectified photography, a process where high resolution photography is used in conjunction with total station survey to develop images without distortion. These elevations can be used to take measurements or map conditions such as erosion, cracking, leaning walls, etc. Condition maps are carried out before beginning the repairs to record the state of the wall both before and after conservation. So far, conservation has focused of stabilizing walls in danger of collapse due to leaning or undercutting. Emergency conservation treatments include supporting leaning walls, using new mud brick to repair eroded wall bases or to stitch cracks, and repairing areas of loss with mud brick and clay plaster. New methods of wall-capping using earthen materials are being tested as an option for protecting the top of walls from further erosion. The next phase of work will address water drainage and develop strategies to divert water away from the foundations of the houses. In parallel to Emergency Conservation measures, a conservation management plan (CMP) will be prepared for the site. The CMP will assess the site's values and the impact of operating the site and opening it up for visitation. The CMP will help guide decisions regarding presentation of the site such as signage, visitor access, maintenance, and protective measures including partial reburial or the construction of a shelter. These measures will ensure the long-term stability of the site and protect this important component of Abu Dhabi's World Heritage listed sites.
